# Seismic deformation in the St. Simeon Monasteries (Qal'at Sim'an), Northwestern Syria

A.S. Karakhanian <sup>a,\*</sup>, V.G. Trifonov <sup>b</sup>, T.P. Ivanova <sup>c</sup>, A. Avagyan <sup>a</sup>, M. Rukieh <sup>d</sup>, H. Minini <sup>d</sup>,  
A.E. Dodonov <sup>b</sup>, D.M. Bachmanov <sup>b</sup>

## Abstract

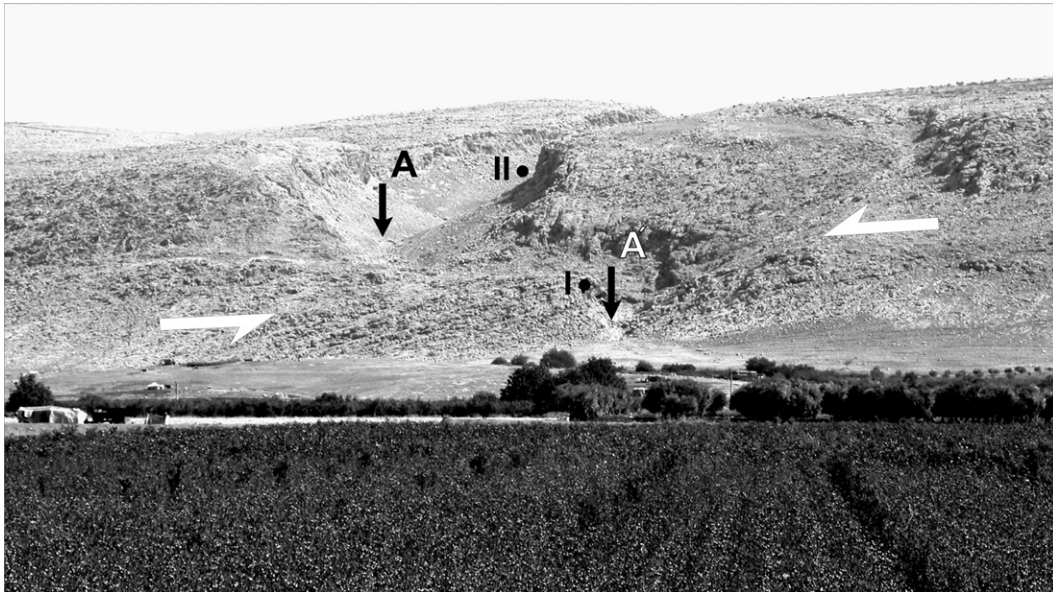
Fig. 3. The St. Simeon Fault near the valley with known Paleolithic caves of Hodedeirieh (Dederiech) I and II (Site 5 in Fig. 2). (A)–(A')—left-lateral strike-slip displacement of the valley thalweg by 250 m. (1) and (2)—the Palaeolithic caves of Hodedeirieh (Dederiech) I and II located directly close to the fault zone.

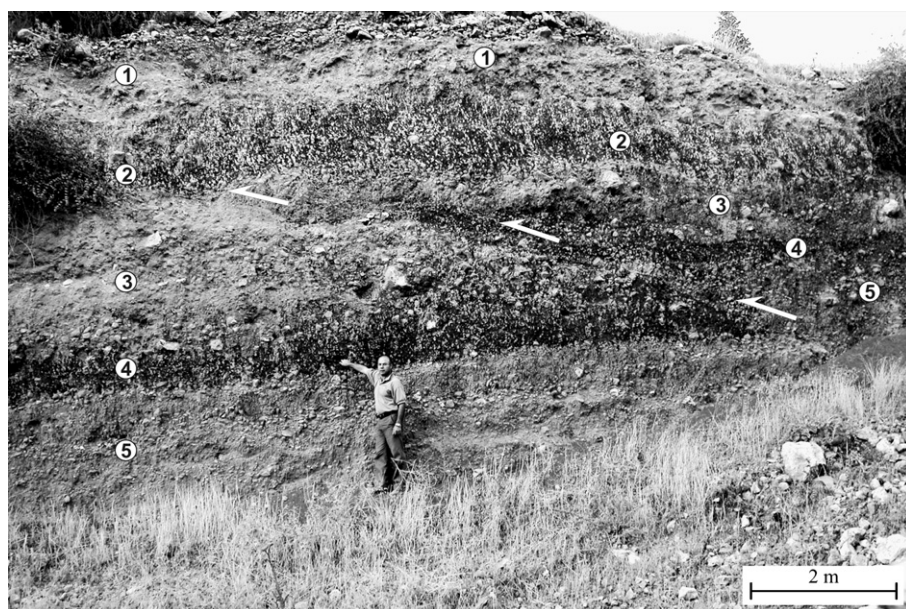
Fig. 6. The reverse fault with displacement amplitude of 1.5 m in the quarry wall, 1 km east of the Gazzavia village (Site 5 in Fig. 2): 1—soil not displaced by the ruptures; 2—dark loams and loamy sand; 3—loam with colluvium debris; 4—dark loam and loamy sand with thin layers of marl and gravel; 5—pebblestone with loamy sand in the base.

A similar picture was observed 5 km north of the Sim'an Ridge, in the quarry wall (Fig. 6). This increasing compression in combination with lateral pushing can lead to transpression and, as a consequence, produce secondary scarps and cracks forming *flower-type* structures near the top of the Sim'an Ridge (Sites A, B and C in Figs. 9; 10b, c).

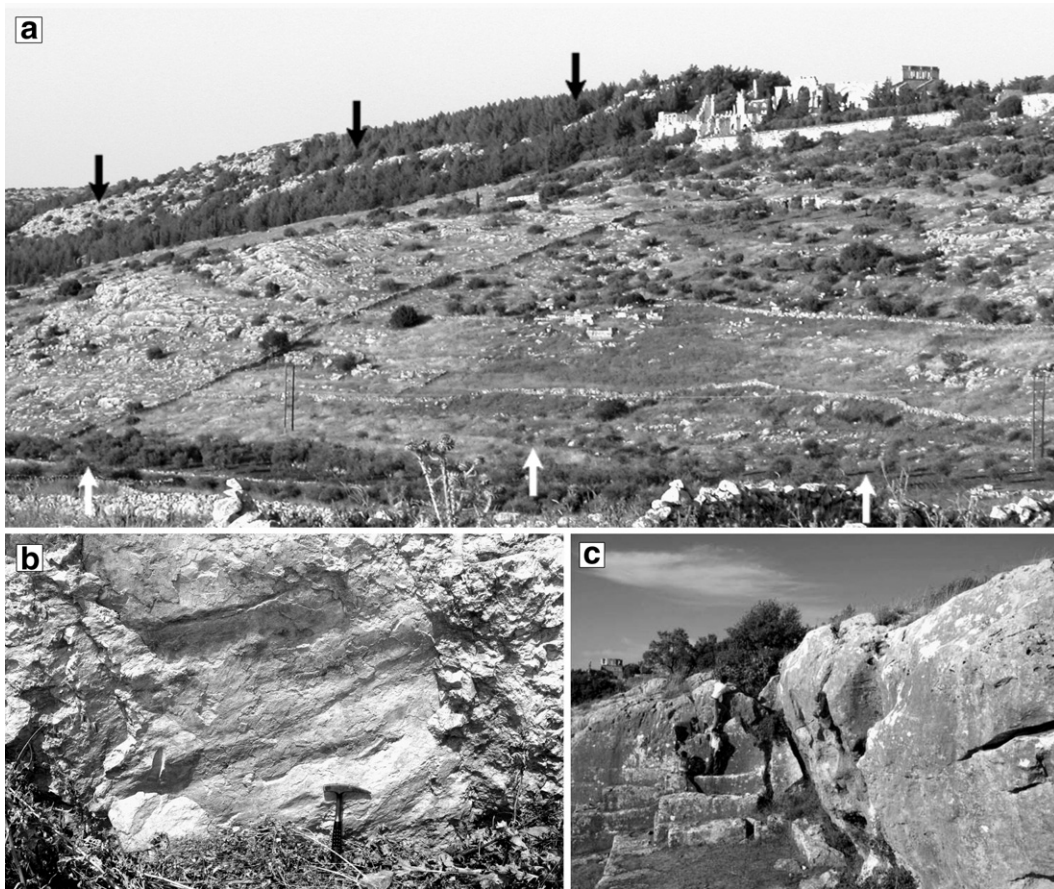
Fig. 10. Photos of fault scarps on the slopes and the crest of the Sim'an Ridge. a—the northern sub-segment is shown by white arrows, and the southern one by black arrows. b—fault scarp on the western slope of the Sim'an Ridge (point B in Fig. 9); c—supposed fault scarp in the area of the St. Simeon Monastery (point C in Fig. 9).

cracks are up to 20 cm and 30 cm thick, respectively. On the western slope and near the crest of the Sim'an Ridge, there are minor scarps located with *en echelon* geometry and bearing unclear horizontal striation (Sites A, B and C in Figs. 9; 10b, c). Part of them can represent secondary fractures and breaks formed during motions along the principal faults. In the meantime, as far as it was possible to establish, the scarp planes dip steeply to the east, opposite to the slope (Figs. 9 and 10).

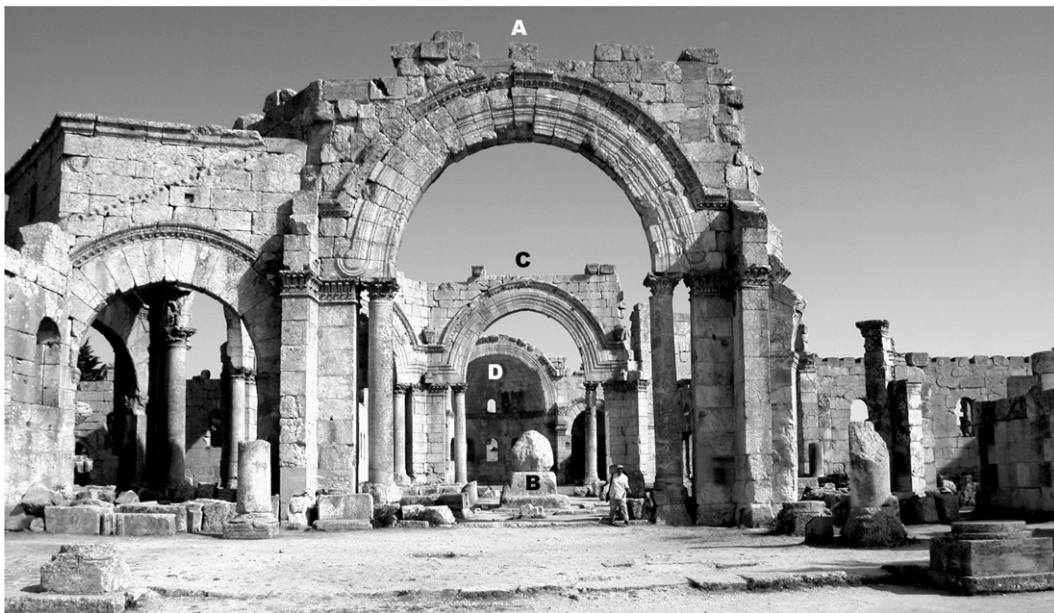
Fig. 16. The main church of St. Simeon—a view from the western wing through the central octagon and the pillar to the eastern wing. Letters A, B and C mark the central symmetry axis of the cathedral drawn in the direction of N100°, along the line connecting the western wing to the pillar; A and C mark the centers of arcs closing the octagon on the west and on the east; B—the pillar; D—the centre of the main apse arch in the eastern wing is displaced by  $3^\circ$  to the east and oriented to N97°.

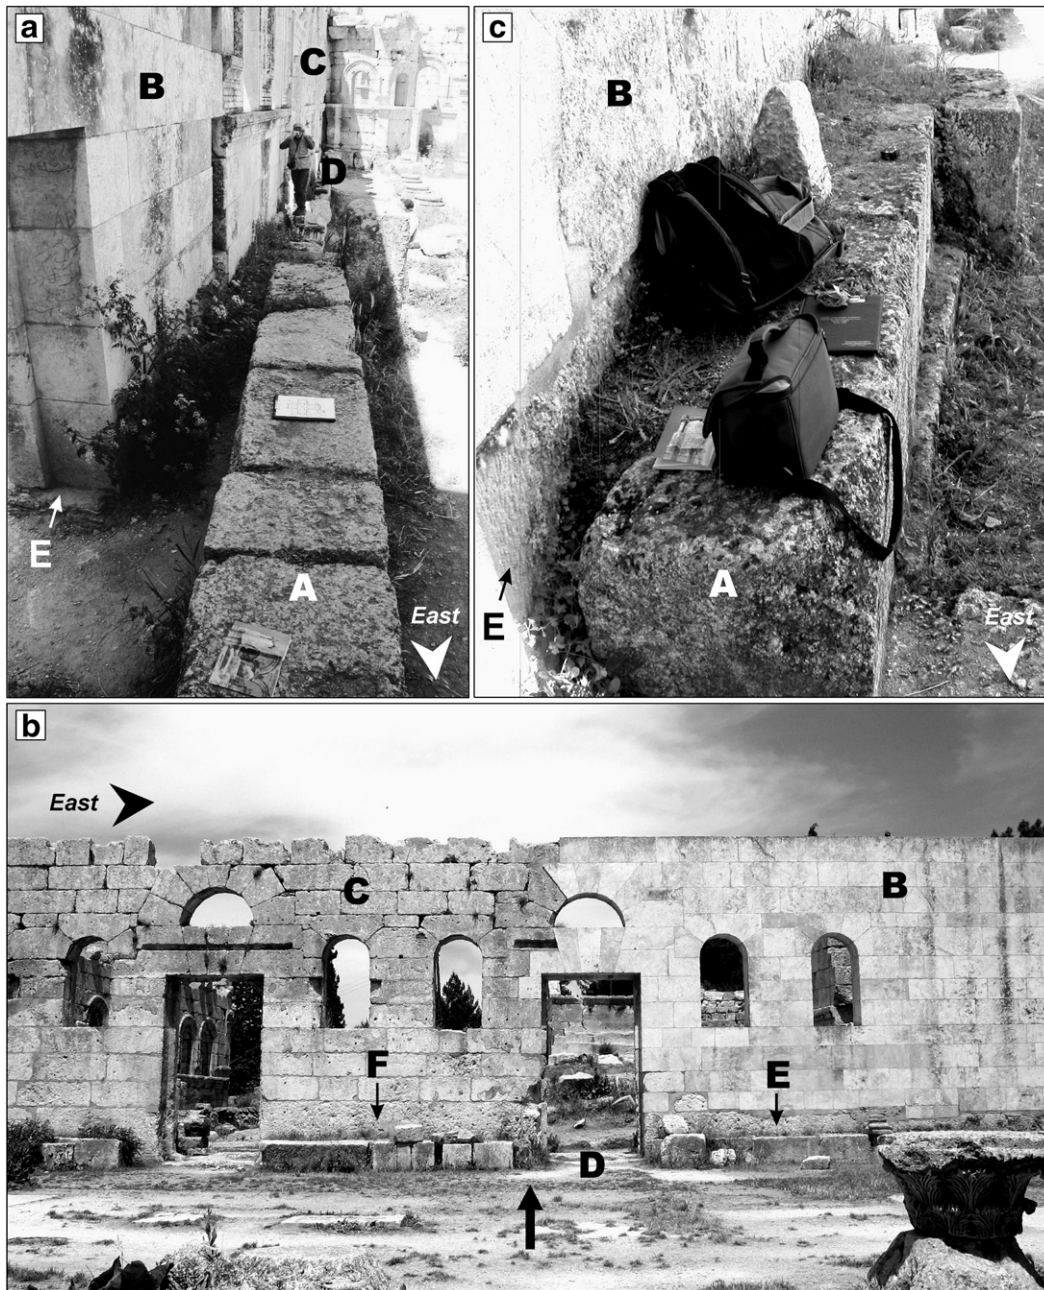
Fig. 18. Old wall fragments in the eastern wing of the main church a—the northern wall of the eastern wing, a view from the Prothesis. (A—the old wall, B—the wall with the masonry restored in the 20th century, C—the wall existing today with the old masonry, D—a part of the old wall fragment joining the wall existing today, E—old foundation, based on which the walls were reconstructed in the 20th century). b—the northern wall of the eastern wing: a view from inside (C—the wall existing today with the old masonry, D—a part of the old wall fragment joining the wall existing today, E—old foundation, based on which the walls were reconstructed in the 20th century, F—a part of the monolithic foundation hollowed in the bedrock) c—the southern wall of the eastern wing, a view from inside (A—the old wall, B—wall with the masonry restored in the 20th century, C—the wall existing today with the old masonry, E—based on which the walls were reconstructed in the 20th century).

(C in Fig. 18a and b). To the east of the junction, the present-day wall was reconstructed in the 20th century, but on the older foundation (B and E in Fig. 18a and b).

A similar pattern is observed inside the opposite, southern wall of the eastern wing: there is a fragment of old wall base, the same as the one found in the *Prothesis* (B in Figs. 17, 18c). The old wall, having a present-day height of two stone blocks and an azimuth of N91°, is oblique with respect to the recent wall that has an azimuth of N94° and stands 0.3 m apart. In the west, the old wall base joins the foundation of the recent wall hollowed in the bedrock. The old wall fragments in the near-altar area bear evidence of a counter-clockwise deformation of the eastern wing by 9° (Fig. 17). An important fact to consider is that the old wall fragments are perpendicular to the iconostasis, altar, and the apse, while the present-day walls join them at an angle

20th century on the older wall foundations (E in Fig. 18a, b and c). Hence, we can distinguish two generations of differently oriented walls within the altar area in the eastern wing: fragments have remained only from walls of Generation 1, oriented  $N91^\circ$ , while walls of Generation 2, existing today, have the azimuth of  $94^\circ$ . Both generations are old and were destroyed in the past. The walls with the azimuth of  $91^\circ$  (Generation 1) are perpendicular to the altar and together with it, apparently, once were parts of the single design. In Generation 2, the walls have
